UNDERWATER FACILITIES
INSPECTIONS
AND
ASSESSMENTS
AT

NAVAL COASTAL
SYSTEMS CENTER
PANAMA CITY, FLA.

FPO-I-85-(17)

JUNE 1985

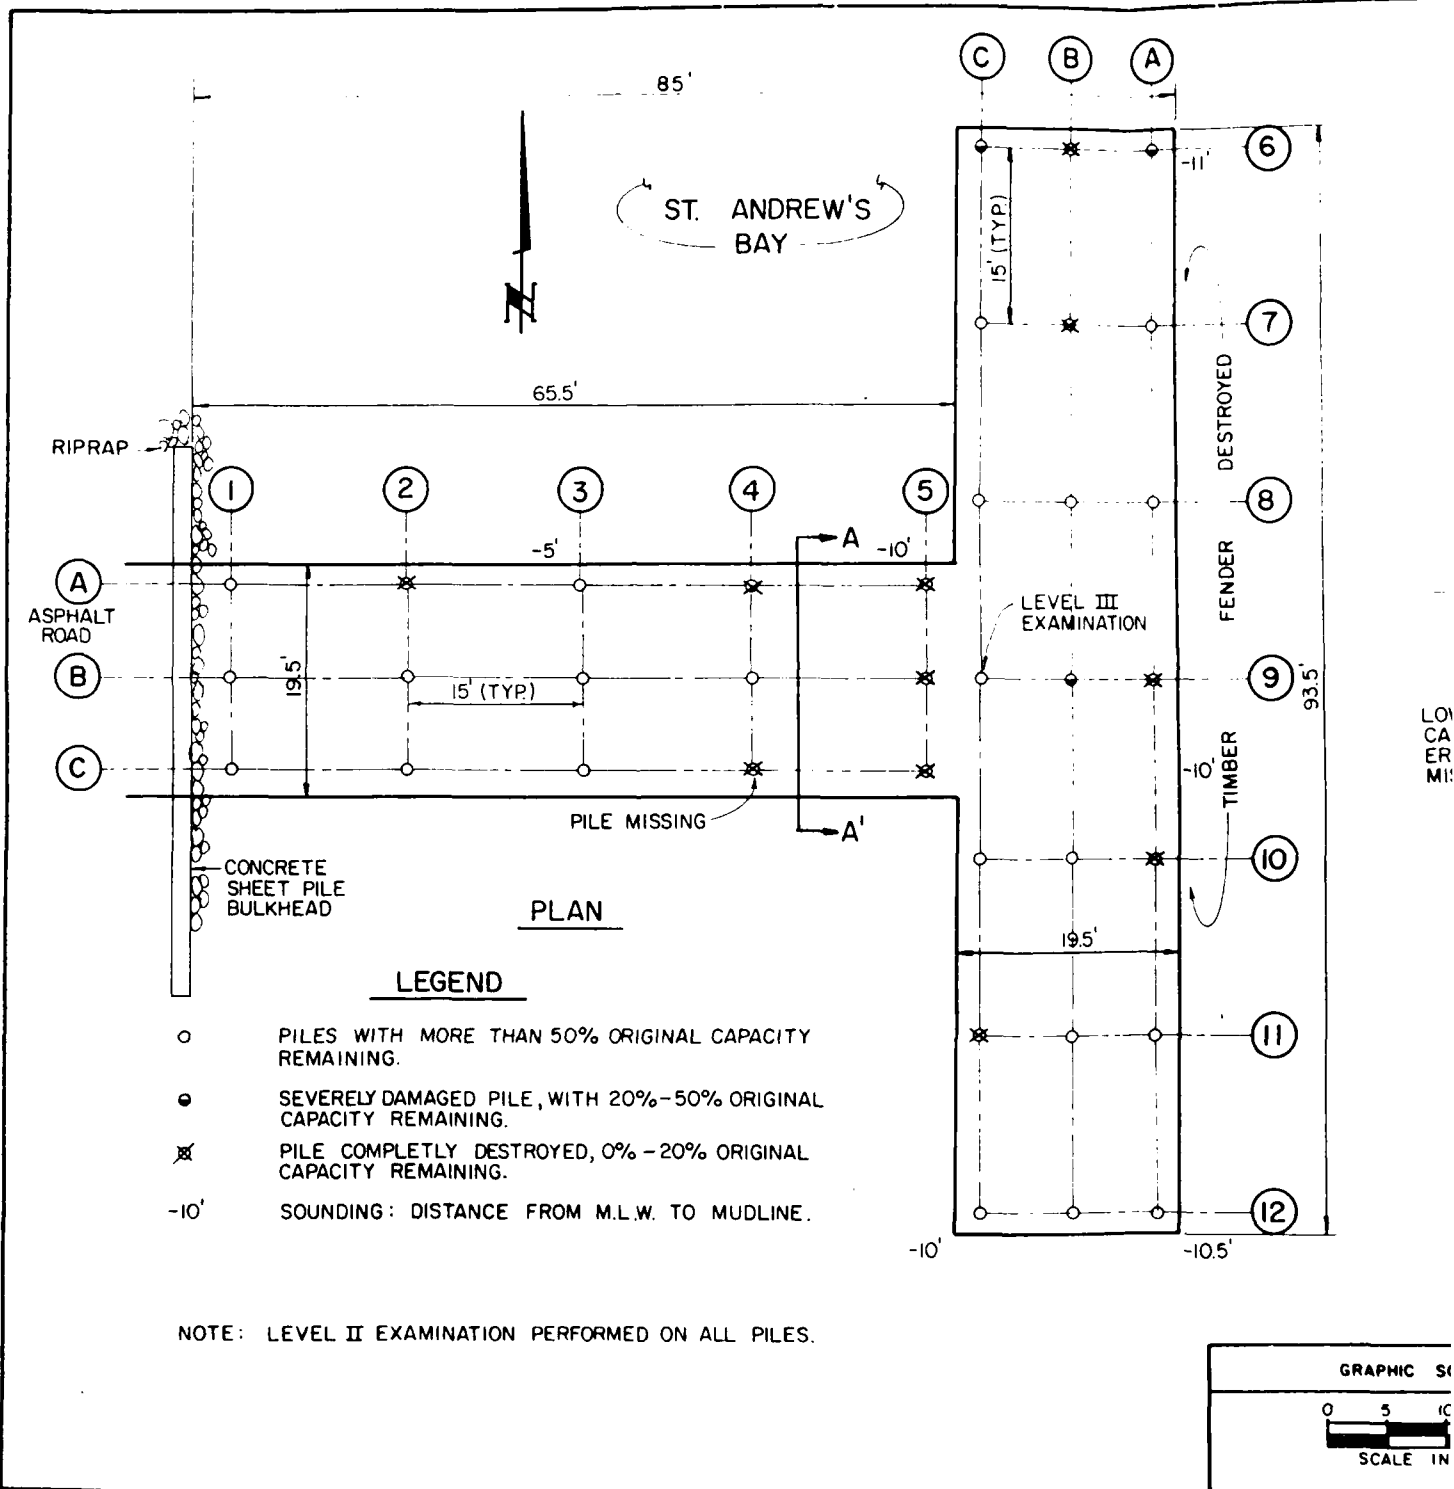
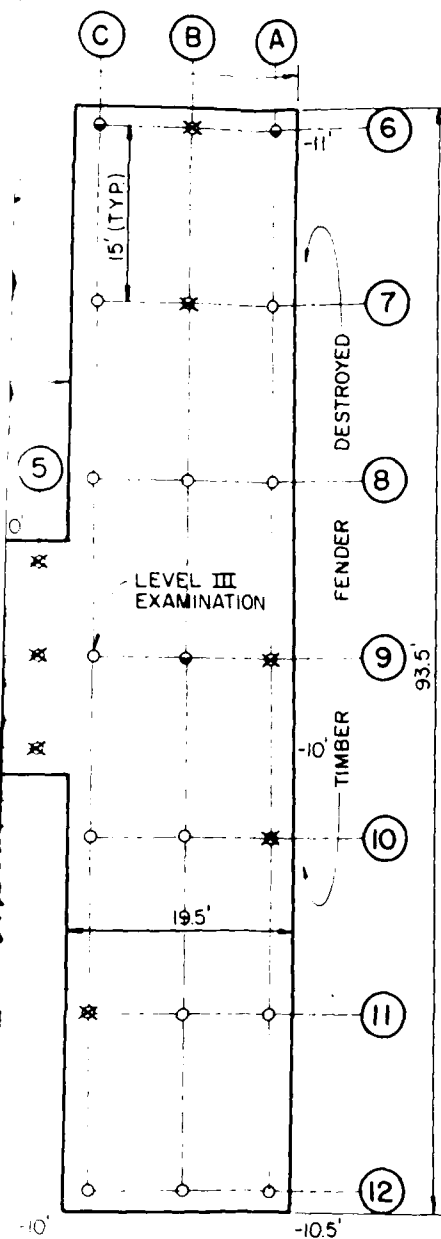
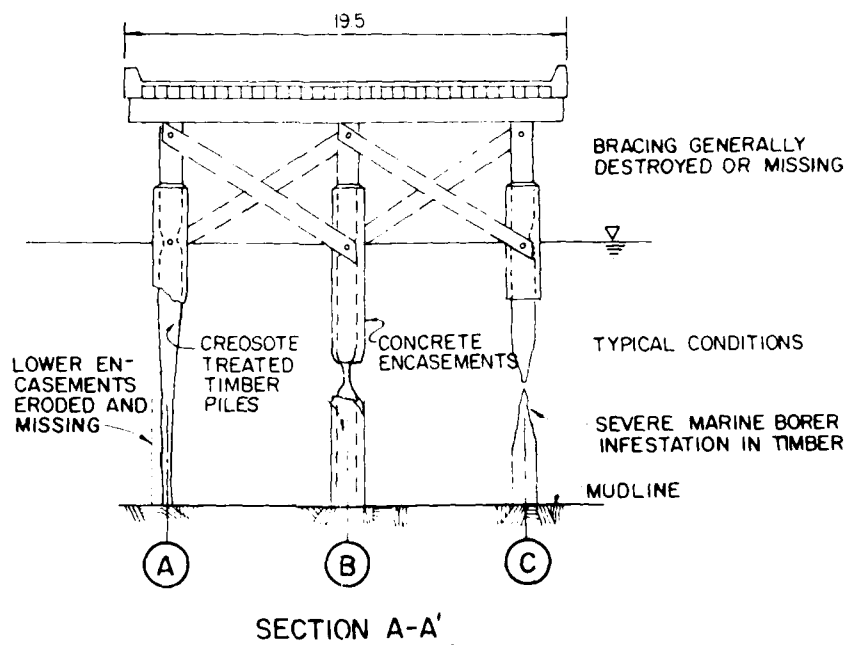
<p>GRAPHIC SCALE</p> <p>SCALE IN FEET</p>	<p>OOLETREE ENGINEERING INC. CORPUS CHRISTI, TEXAS</p>	<p>CHESAPEAKE DIVISION NAVAL FACILITIES ENGINEERING COMMAND WASHINGTON, D.C. NAVAL COASTAL SYSTEMS CENTER PANAMA CITY, FLORIDA PIER 136</p>	<p>FIG NO. 3</p>
---	--	---	----------------------

Pier 136 is a timber pile foundation structure with a concrete deck. The pile foundation consists of 12 bents of three timber piles per bent. The pier is "T" shaped, with a concrete deck width of 19.5 feet and a total length of 85 feet. Concrete encasements have been installed on all piles, circa 1968, to structurally restore damage which had resulted from marine borer infestation (See Figure 3). At the time of this inspection, pier use was restricted due to suspected structural weakness.

Concrete encased timber piles that supported the dock were extensively damaged. Below the waterline, the concrete encasements were typically eroded and ineffective, leaving the reinforcing steel and timber largely exposed to seawater. Much of the remaining concrete is soft, poor quality material. Exposed timber was infested with marine borers (Limnoria) which had completely destroyed 11 piles (See Photo 1). Three additional piles had been reduced to the extent that their bearing capacity was minimal. Specific conditions of piles are as follows:

<u>PILE ID</u>	<u>CONDITION</u>
1A	Encased into riprap, some encasement erosion at bottom.
1B	Encased into riprap, some encasement erosion at bottom.
1C	Encased into riprap, some encasement erosion at bottom.

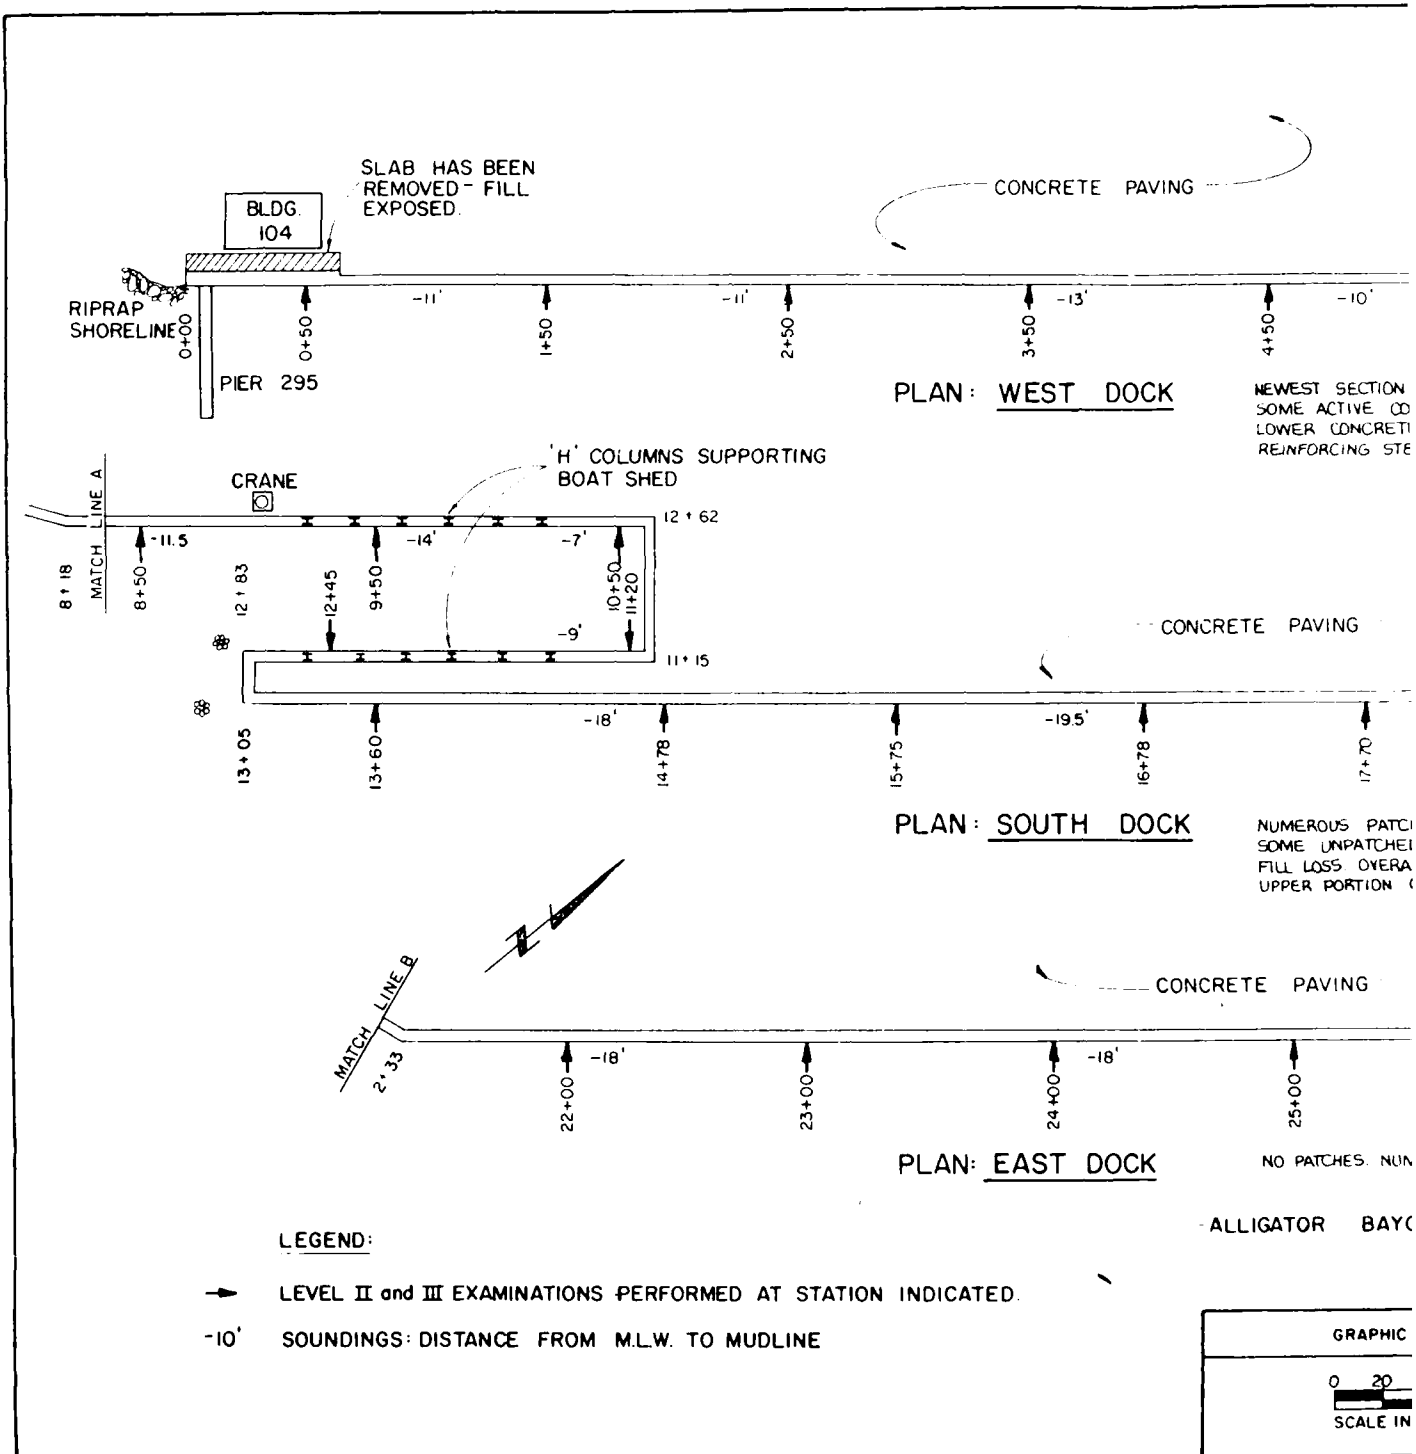
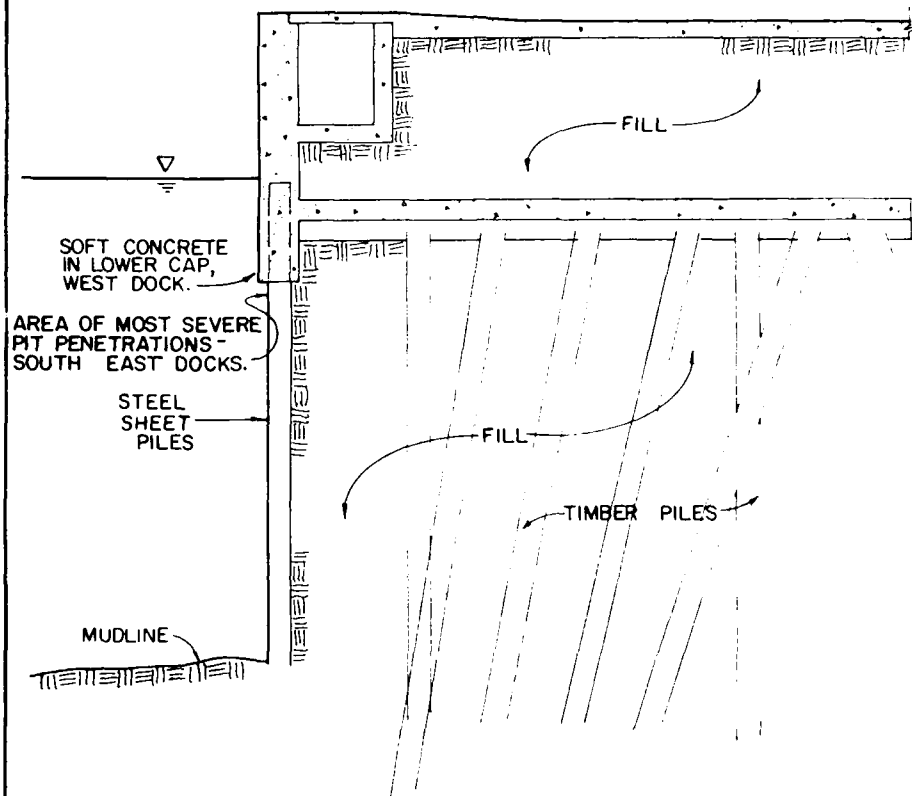
<p>SCALE IN FEET</p>		NAVAL COASTAL SYSTEMS CENTER PANAMA CITY, FLORIDA BULKHEAD 146	FIG. NO. 5

The lower portion of the concrete cap consisted of very soft, poor quality concrete. The material crumbled and broke with very little impact, and reinforcing steel was already exposed at several locations (See Photo 5). This condition gradually improved upward from the bottom of the cap, and concrete near and above the waterline appeared to be satisfactory. It was observed that even the softest areas of concrete were covered with marine growth, which indicates that the cap has stabilized and is not continually sloughing away.

South Dock, Station 8+18 to 21+33: This section of dock represents older, but similar construction. The steel sheet piles have been actively corroding, with most advanced section losses occurring at the upper portion of the steel sections near

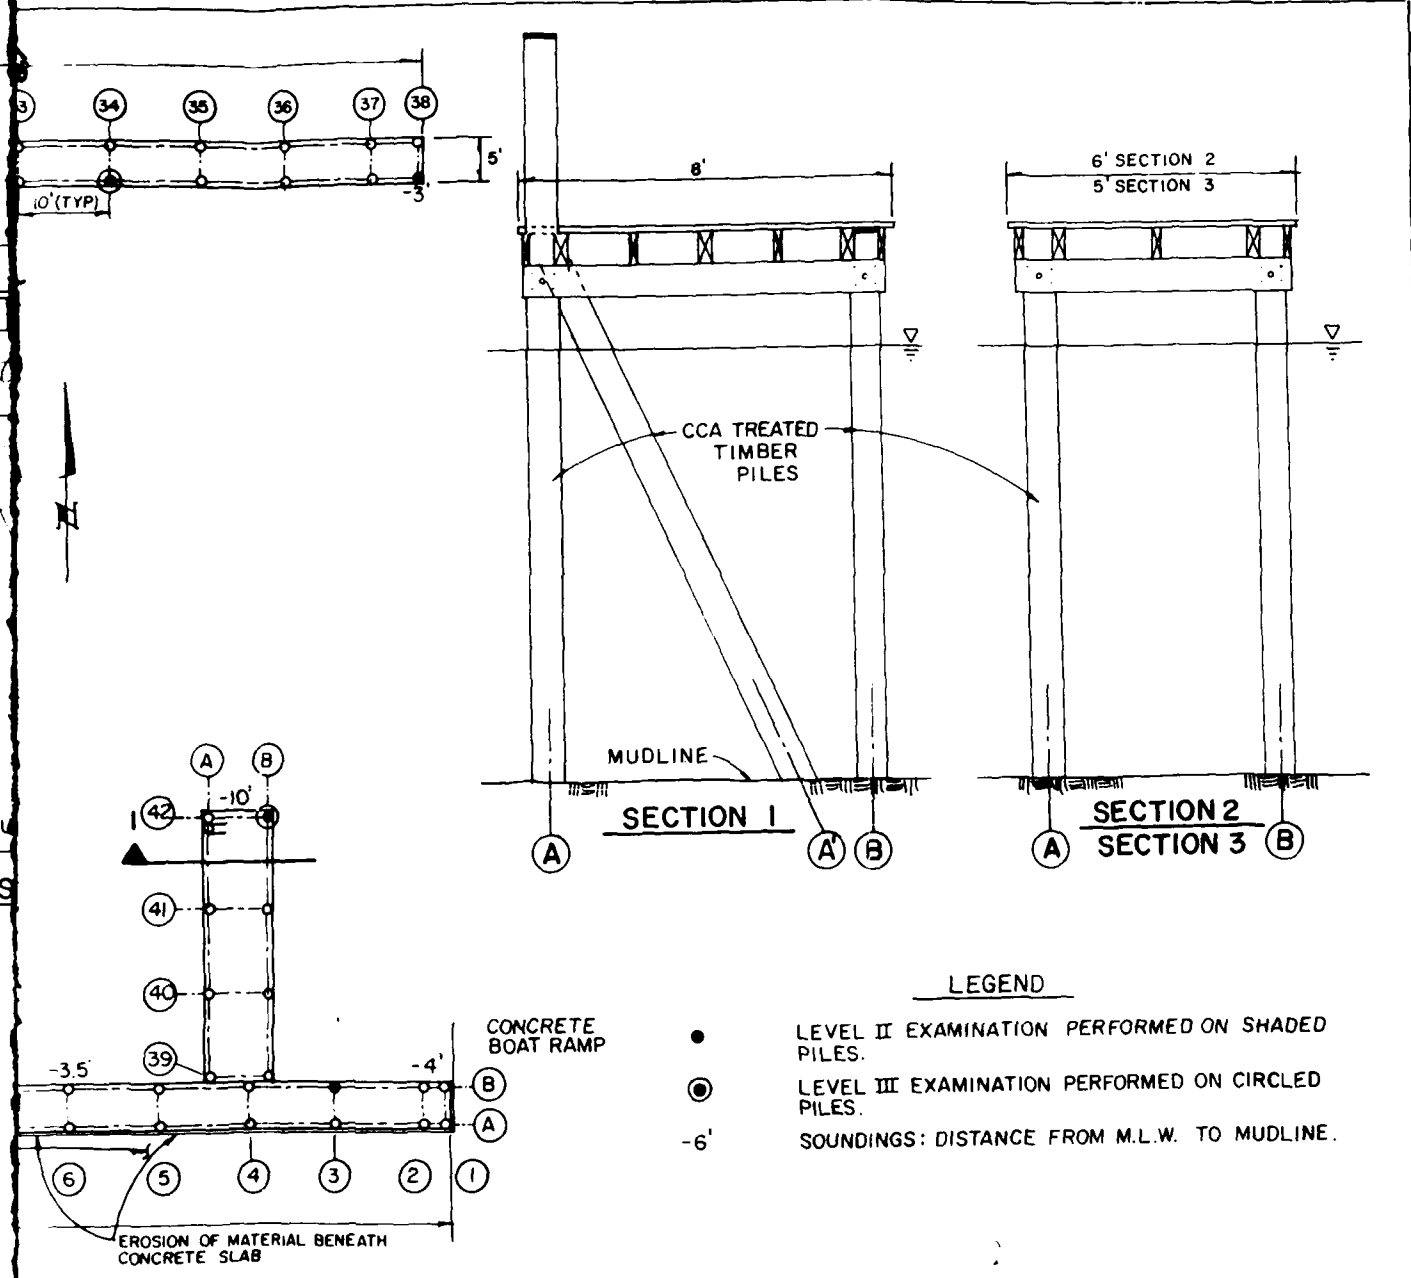
PHOTO 15

All timber piles, deck, and connecting hardware were found to be in excellent condition. No sign of decay or marine borer activity was detected (See Photo 15).

Shoreline erosion control should be implemented at the marina basin shoreline beneath the concrete slab. The initial recommended procedure is to manually place sacks of pre-mix concrete in the voids and along the tidal zone. The shoreline should be monitored and additional protection added as required periodically to maintain stability. Estimated cost to perform this work is \$5,000 (See Appendix, Cost Estimate Calculations). The timber pier should be included in a regularly scheduled inspection program and re-examined in three years.

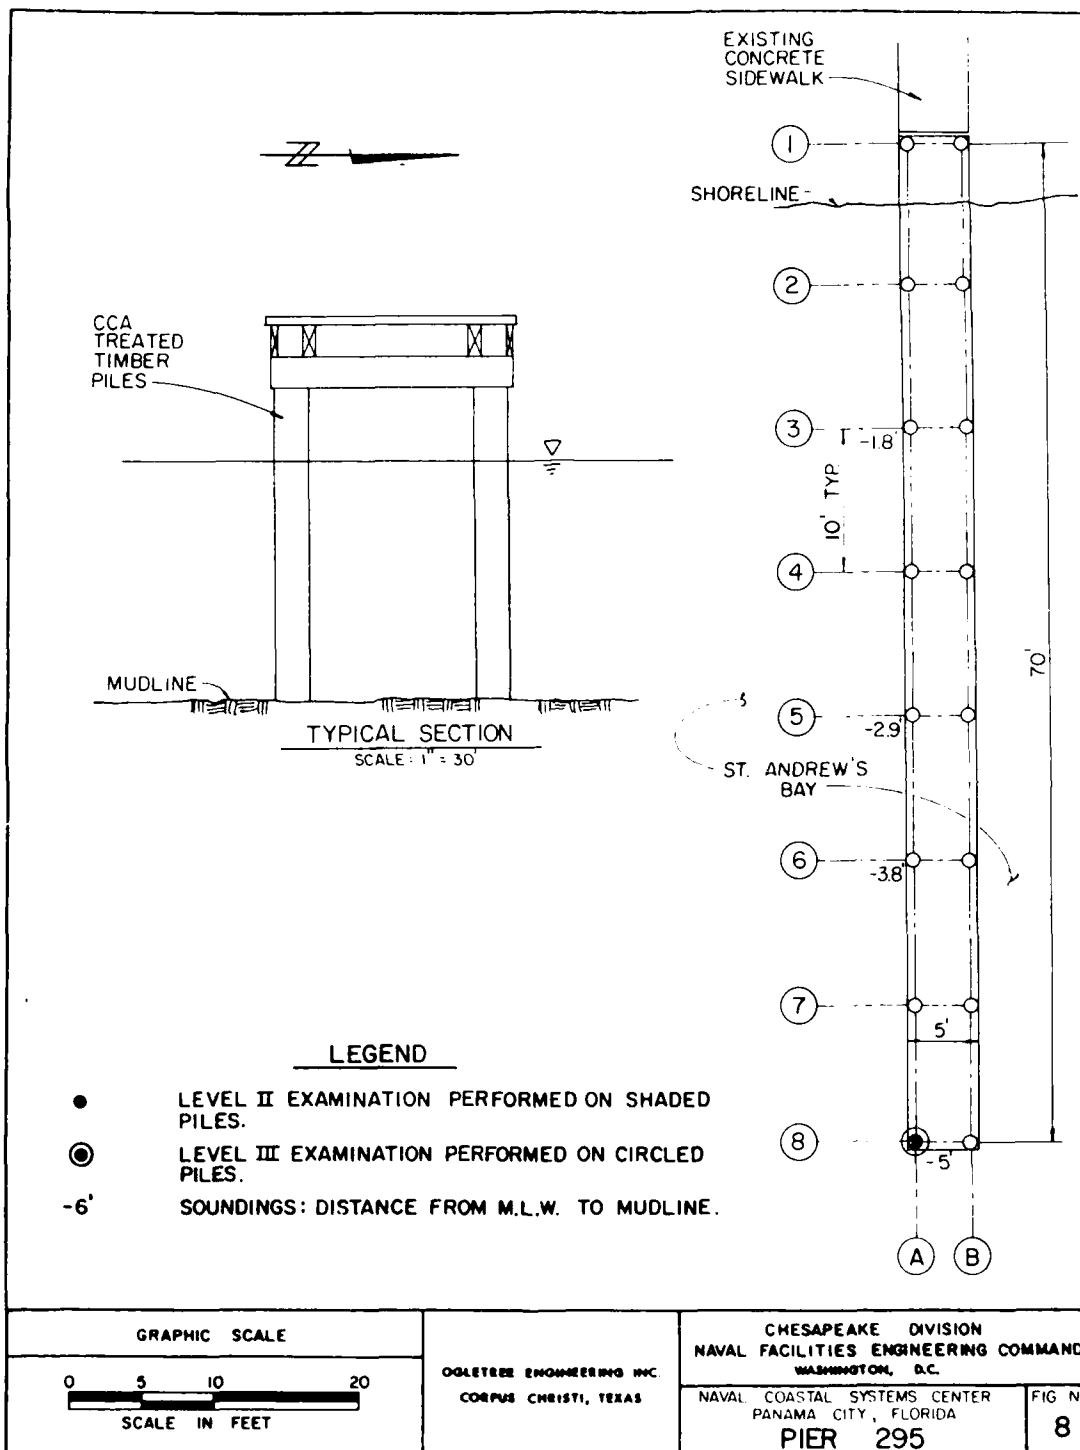
PHOTO 17

All timber components and connecting hardware are in excellent condition (See Photos 17 and 18). No sign of significant decay or marine borer activity was detected at any structural member. Untreated timbers forming a fender system were decaying.

Pier 295 should be included in a regular inspection program where all timber structures are examined every three years.

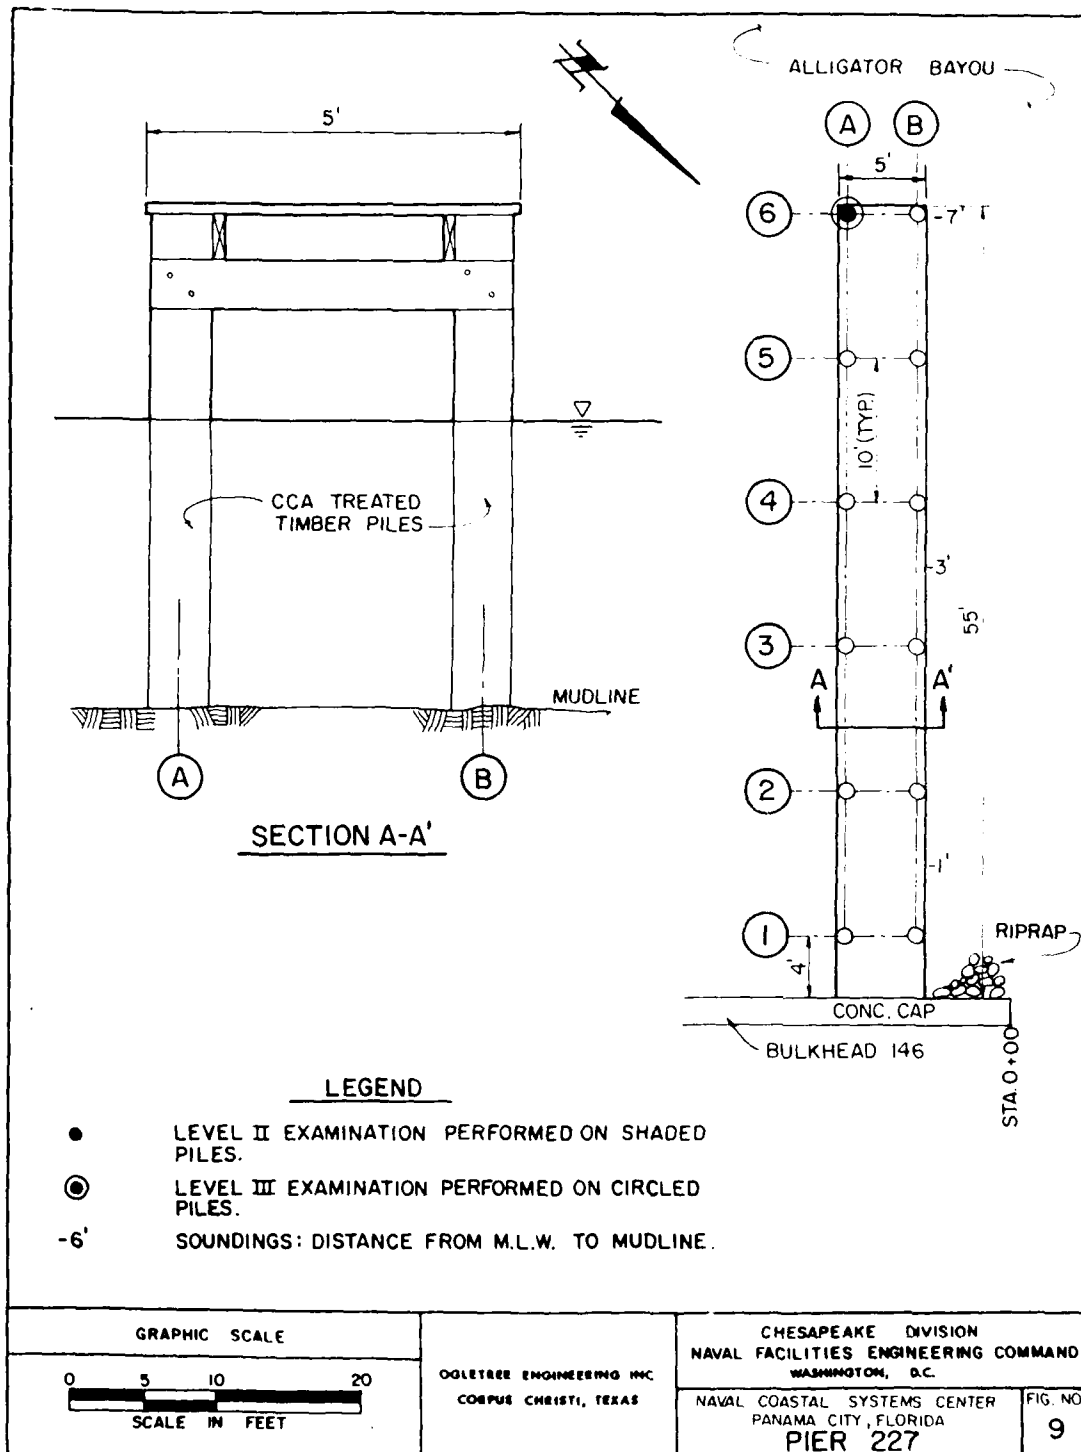
PHOTO 19

Pier 227 is a pedestrian timber structure supported by 12 CCA treated piles. The pier, 55 feet long and 5 feet wide, is in Alligator Bayou on the west end of Bulkhead 146 (See Figure 9 and Photo 19).

Pier 227 should be included in a regular inspection program where all timber structures are examined every three years.

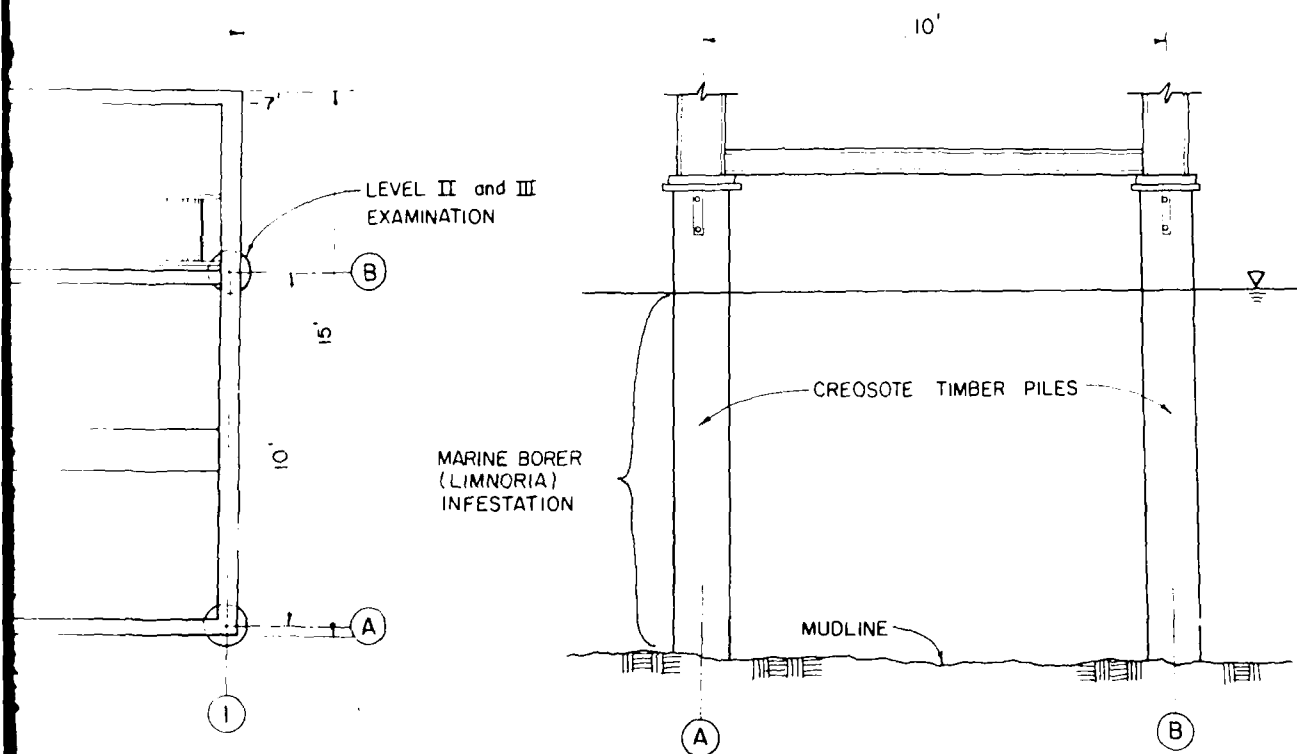
GRAPHIC SCALE	OGLETREE ENGINEERING INC CORPUS CHRISTI, TEXAS	CHESAPEAKE DIVISION NAVAL FACILITIES ENGINEERING COMMAND WASHINGTON, D.C.	
0 1 2 4 B SCALE IN FEET			FIG NO. 10

Monorail 224 is a lifting mechanism at the north end of Bulkhead 146, supported by the bulkhead on one end and by two timber piles in the water (See Figure 10).

Marine borer attack on the two timber piles should be promptly arrested before structural damage becomes significant. Flexible barrier wraps, such as Pile-Gard, can be installed on the piles. These barrier wraps cut off the oxygen supply to the timber, killing existing borers and preventing further infestation. Barrier wraps could be installed on these two piles by Navy personnel. Cost for this installation would be approximately \$1,000. (Due to the small size and simplicity of this repair, "in-house" diving personnel could perform this work economically.)

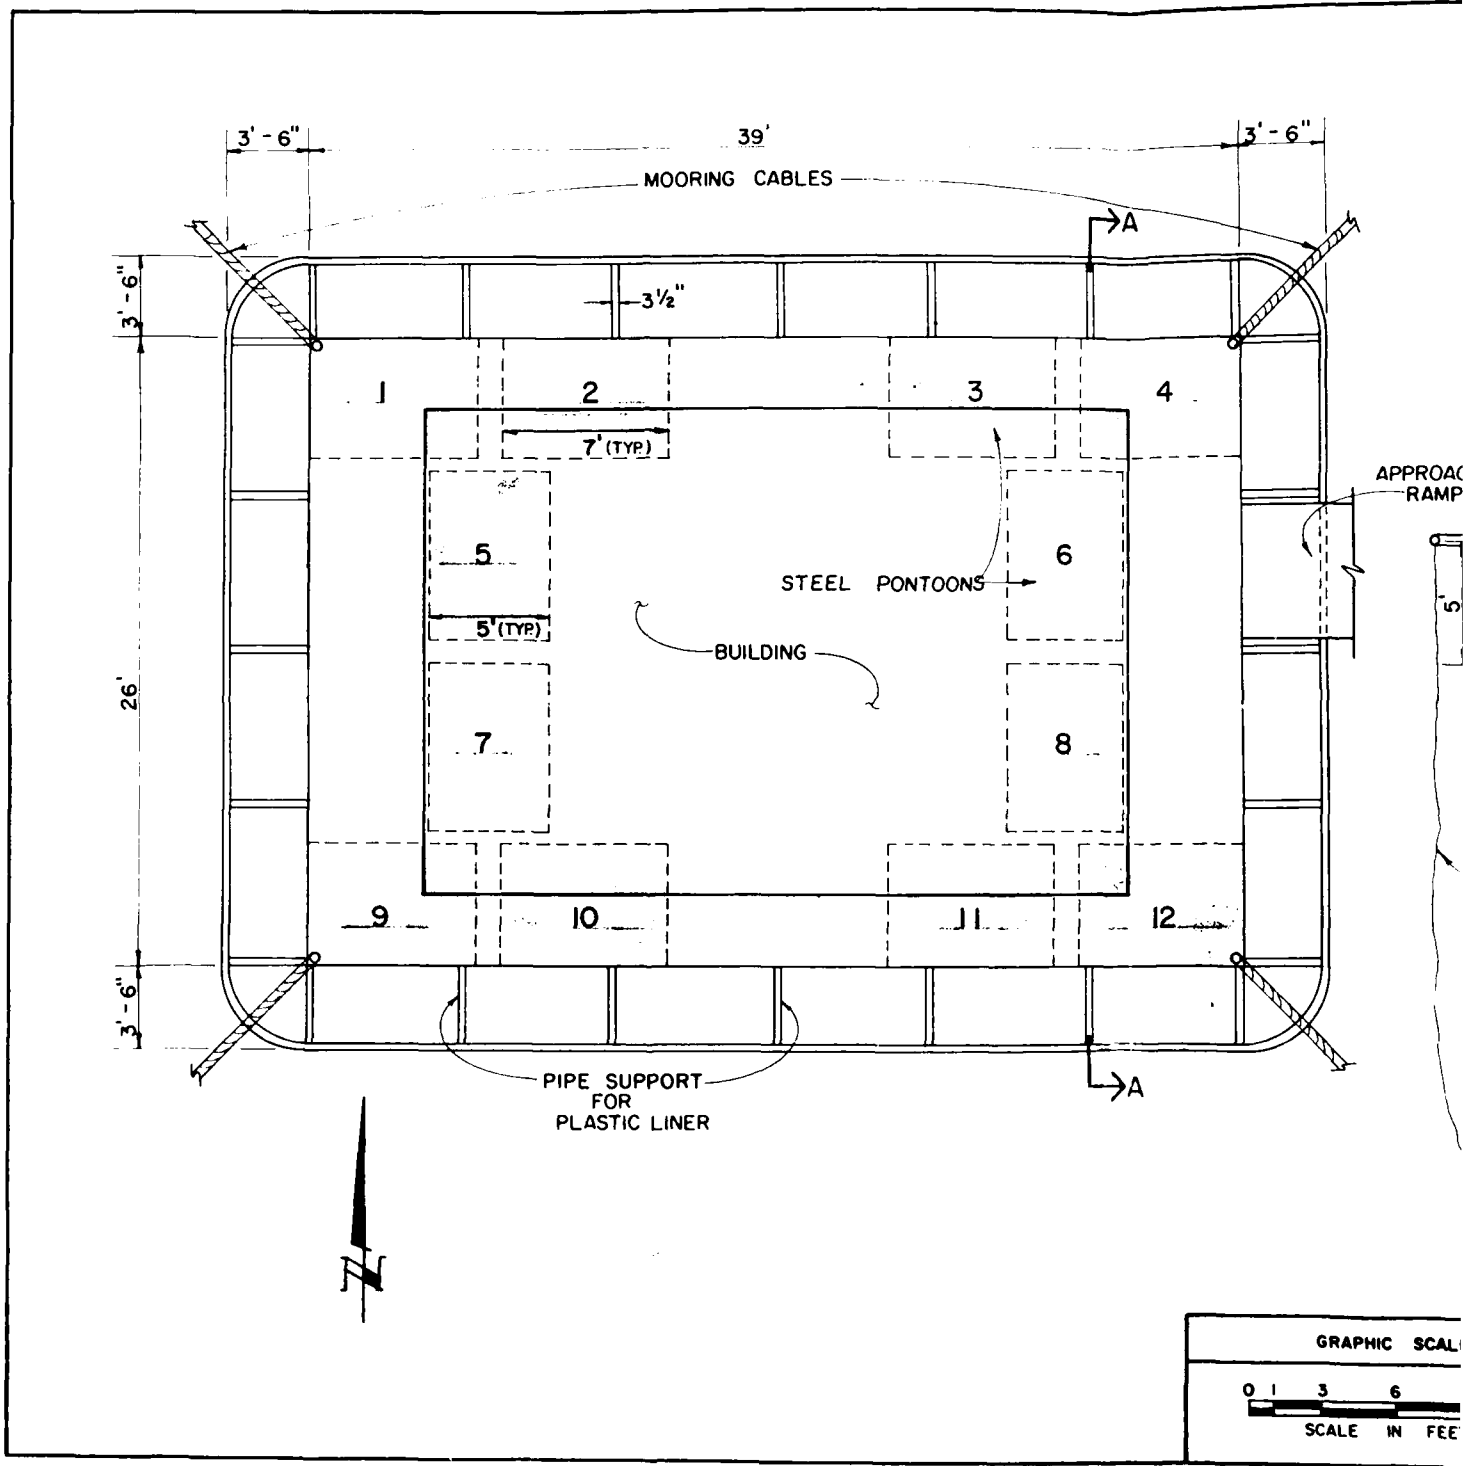
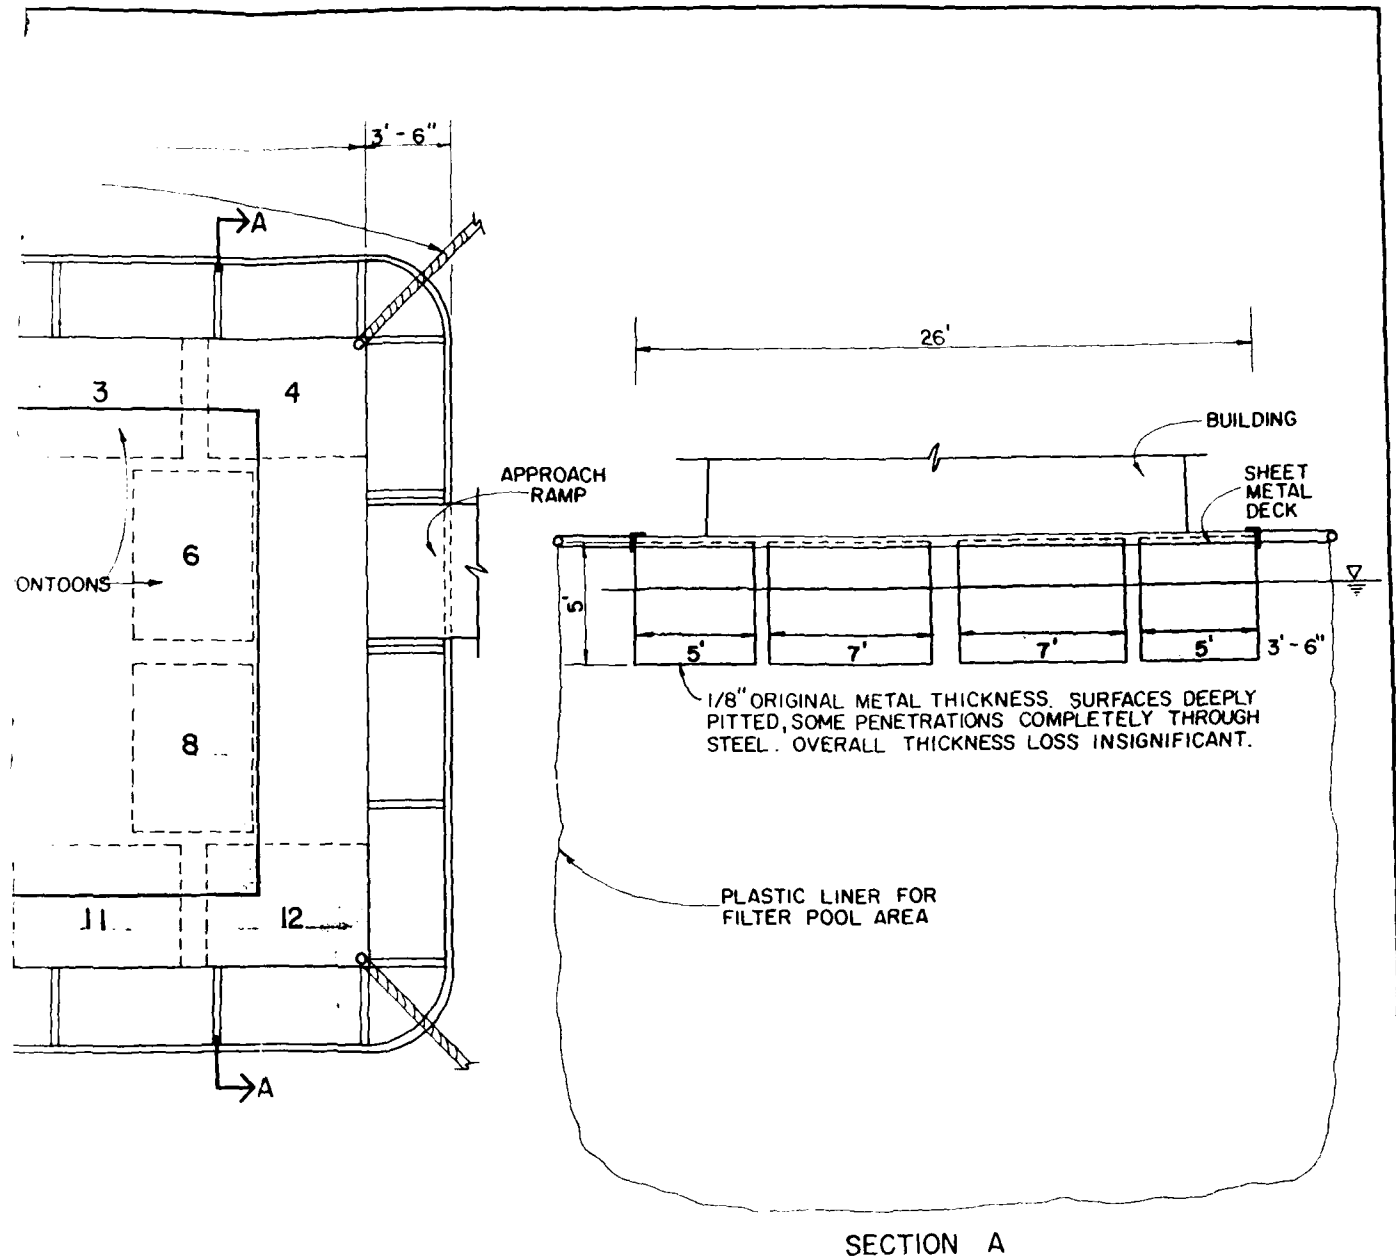
Pontoon Barge: Steel pontoons have severe corrosion pits, in some cases completely penetrating the steel. Overall section losses are insignificant.

Flotation can be preserved by injection of an expansive water insensitive foam into the pontoons. This project should include cutting access ports in the pontoons and removing moisture and deleterious material before application of the foam. The steel pontoons would then serve as a form, or mold, for flotation provided by the foam, and future corrosion penetrations would be less significant. Estimated cost to perform this repair is \$28,800 (See Appendix, Cost Estimate Calculations).

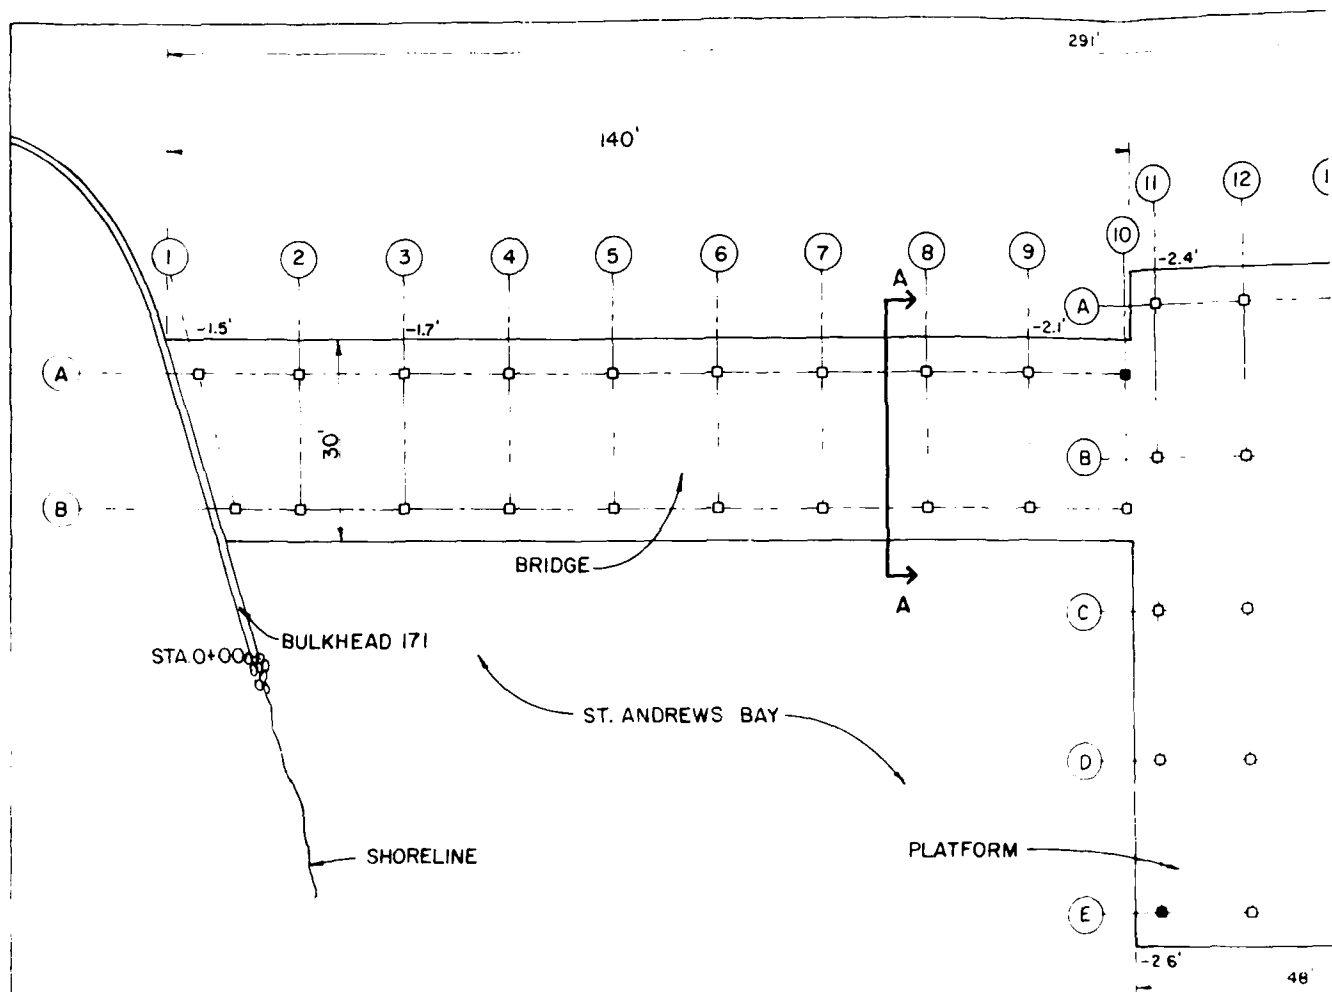
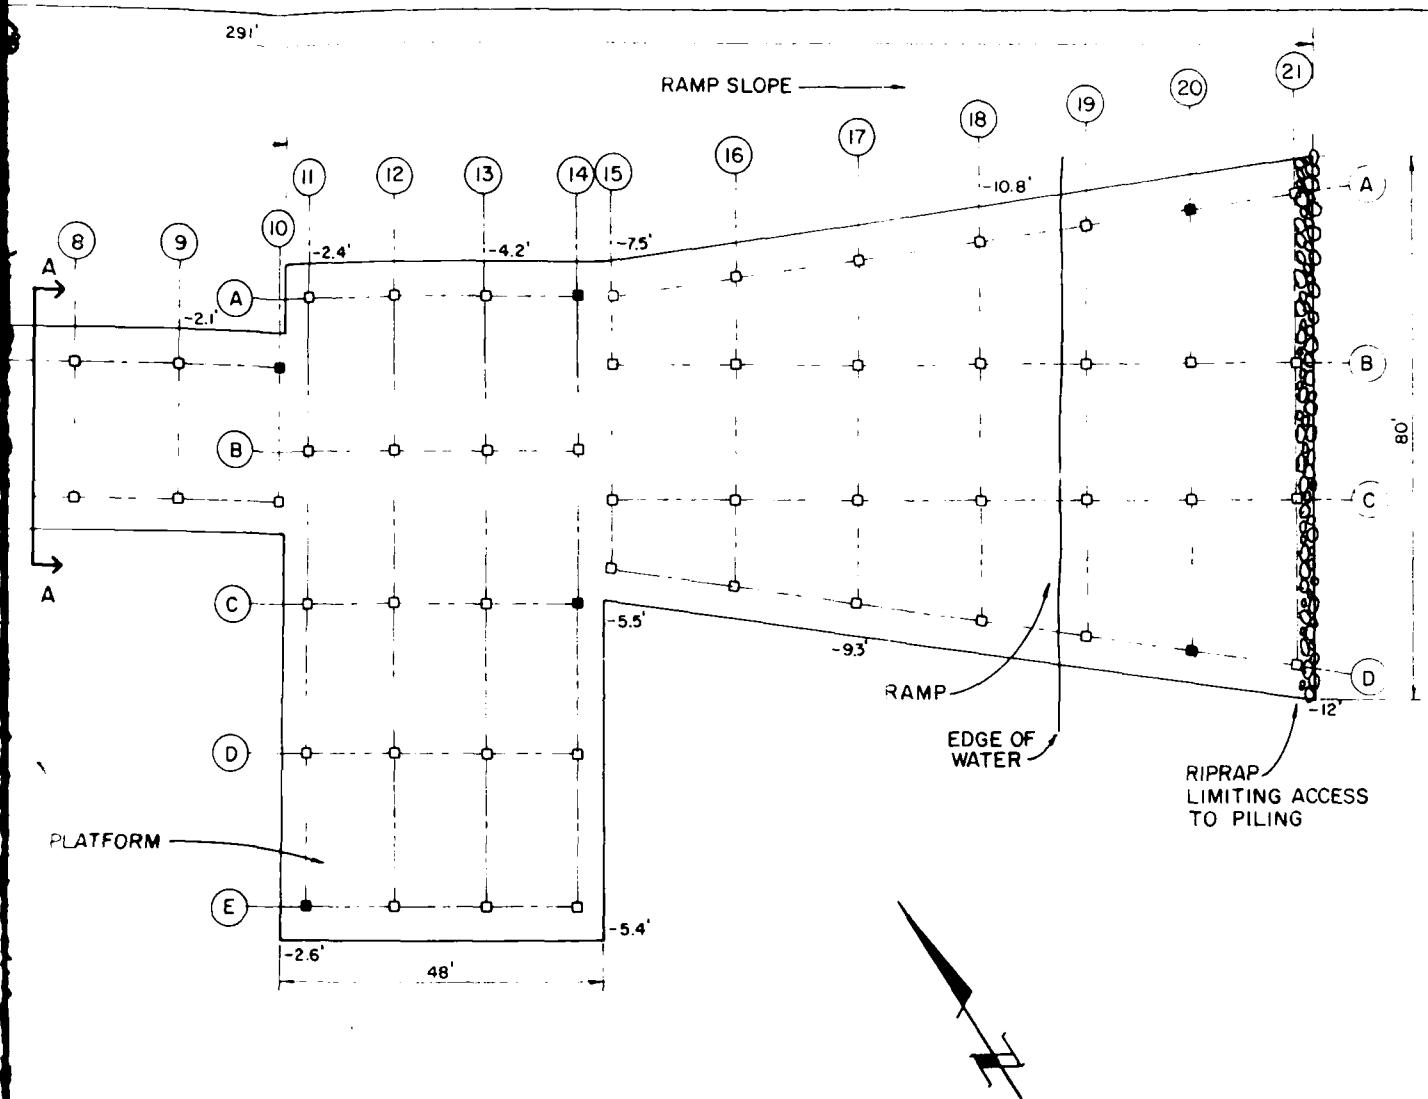
<p>GRAPHIC SCALE</p> <p>SCALE IN FEET</p>	<p>OGLETREE ENGINEERING INC CORPUS CHRISTI, TEXAS</p>	<p>CHESAPEAKE DIVISION NAVAL FACILITIES ENGINEERING COMMAND WASHINGTON, DC NAVAL COASTAL SYSTEMS CENTER PANAMA CITY, FLORIDA PIER 368</p>
		<p>FIG NO 14</p>

Pier 368 provides a ramp into St. Andrews Bay for various craft. The structure is pre-cast concrete, supported by 68 square concrete piles (See Figures 14 and 15).

No immediate maintenance needs are evident. The structure should be reinspected in six years to detect development of any potential problems.
